WORLD'S STRONGEST INTERSECTION LEAVES TEENAGE YEARS BEHIND

By Wayne Jones, P.E. and Timothy Murphy, P.E.

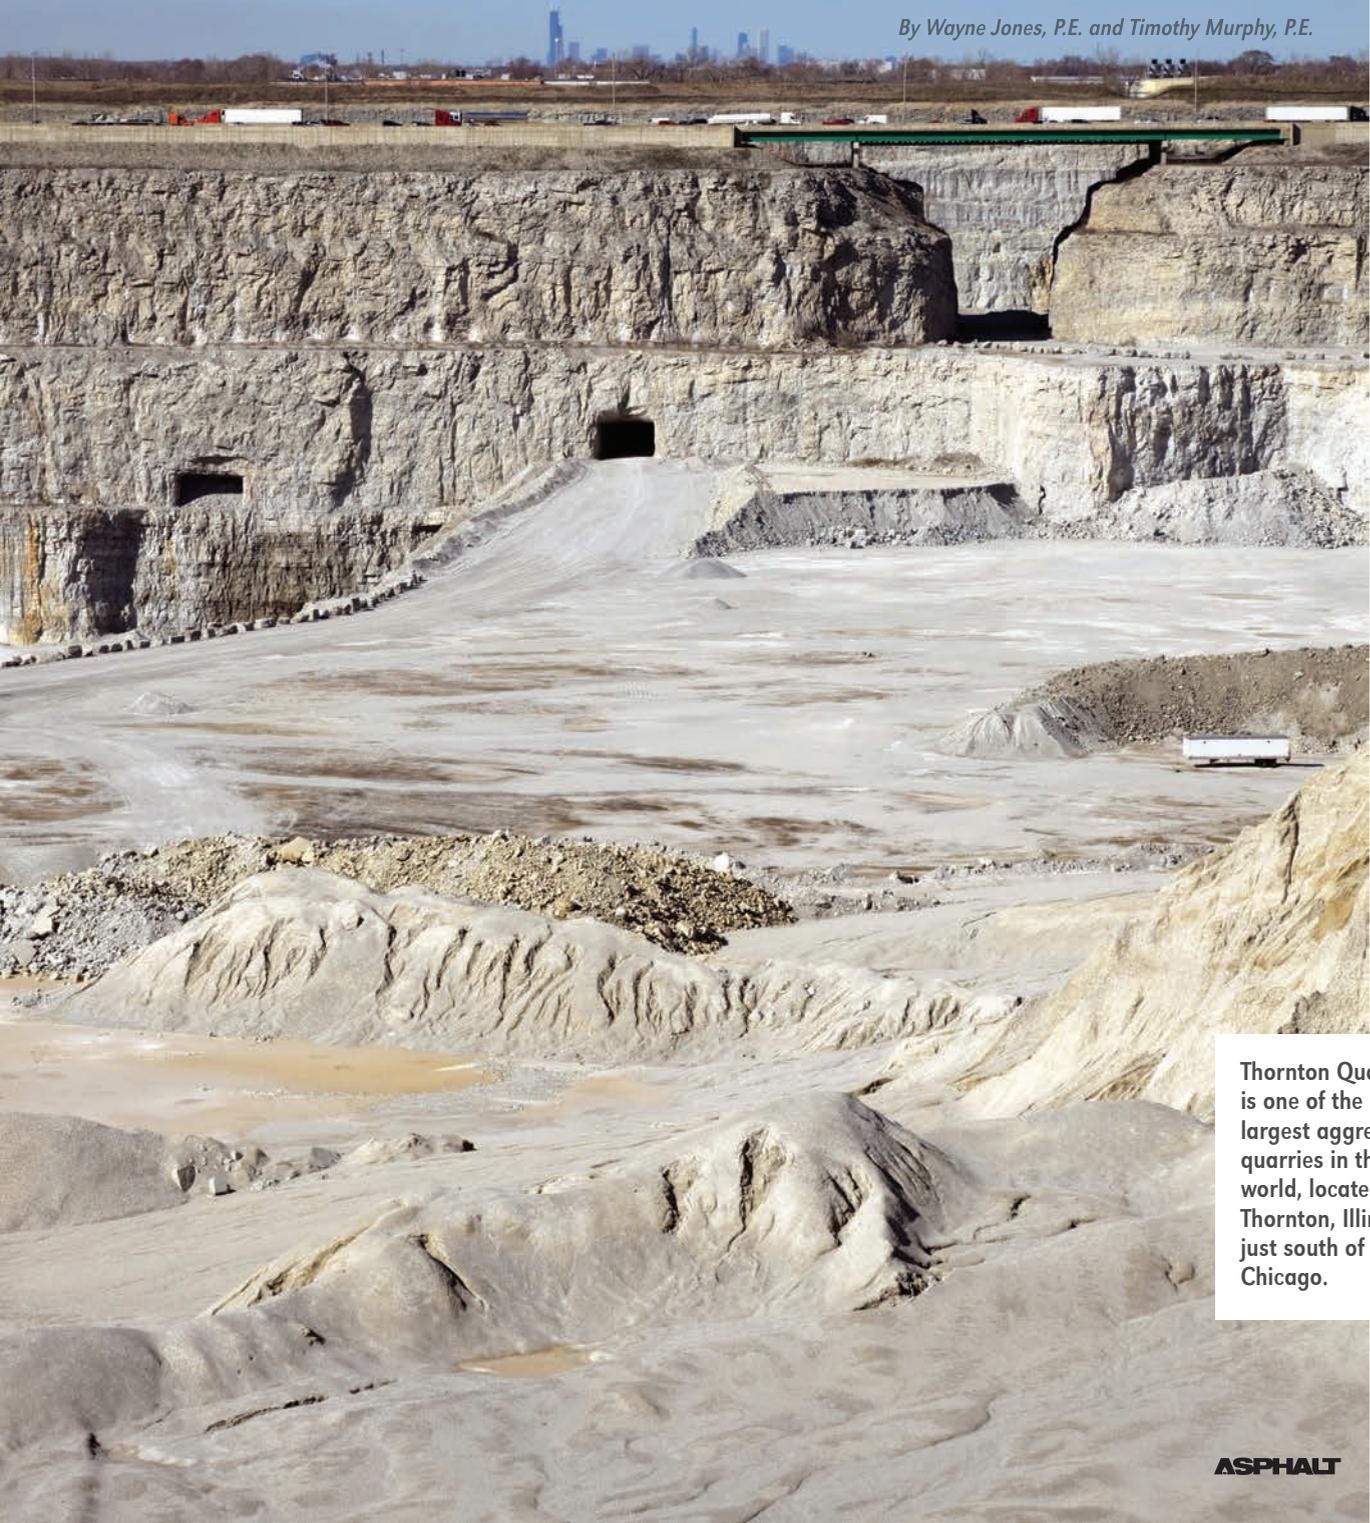
Thornton Quarry is one of the largest aggregate quarries in the world, located in Thornton, Illinois just south of Chicago.

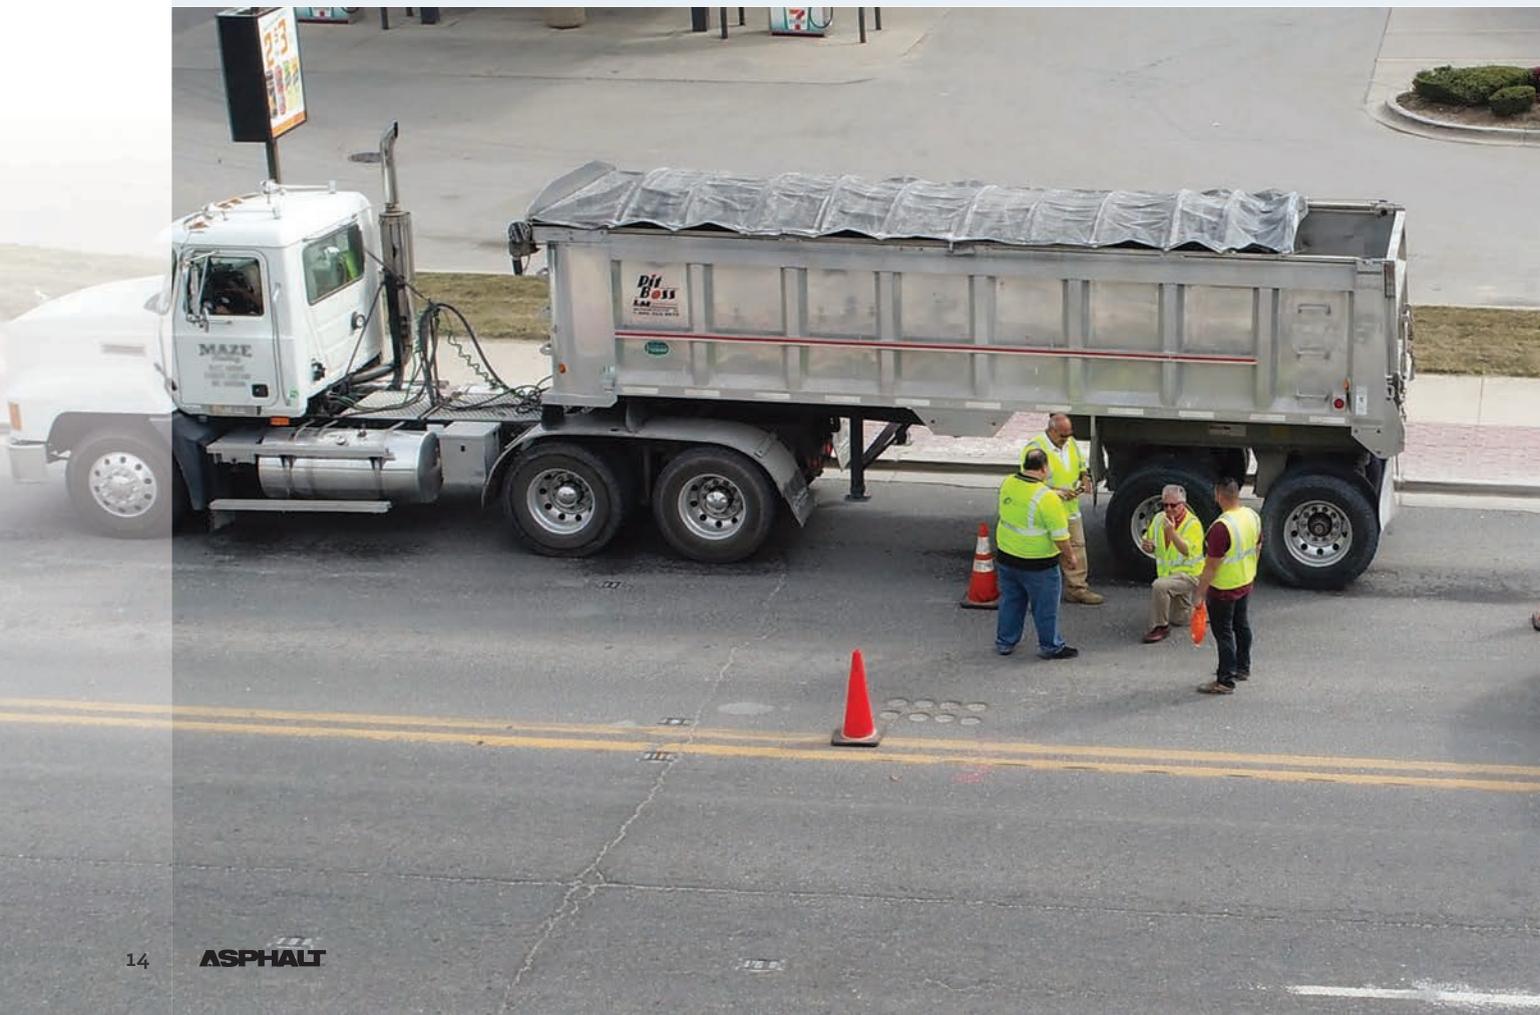
One of the first intersections to be rebuilt using this four-step process was the intersection of Williams and Margaret Streets in downtown Thornton, Illinois, in 1998. A sign near the intersection proclaims "Thornton Quarry, Largest Limestone Quarry in the World."

Thornton quarry produces up to 50,000 tons of stone each day and most of this aggregate is shipped by truck and passes through the intersection of Williams and Margaret streets. The quarry provides most of the mineral aggregates used throughout south Chicago and northwest Indiana, and even gets trucked as far away as southwest Michigan. Because of the quarry's excellent quality, paving contractors are able to utilize this aggregate source to ensure consistent asphalt mix production.

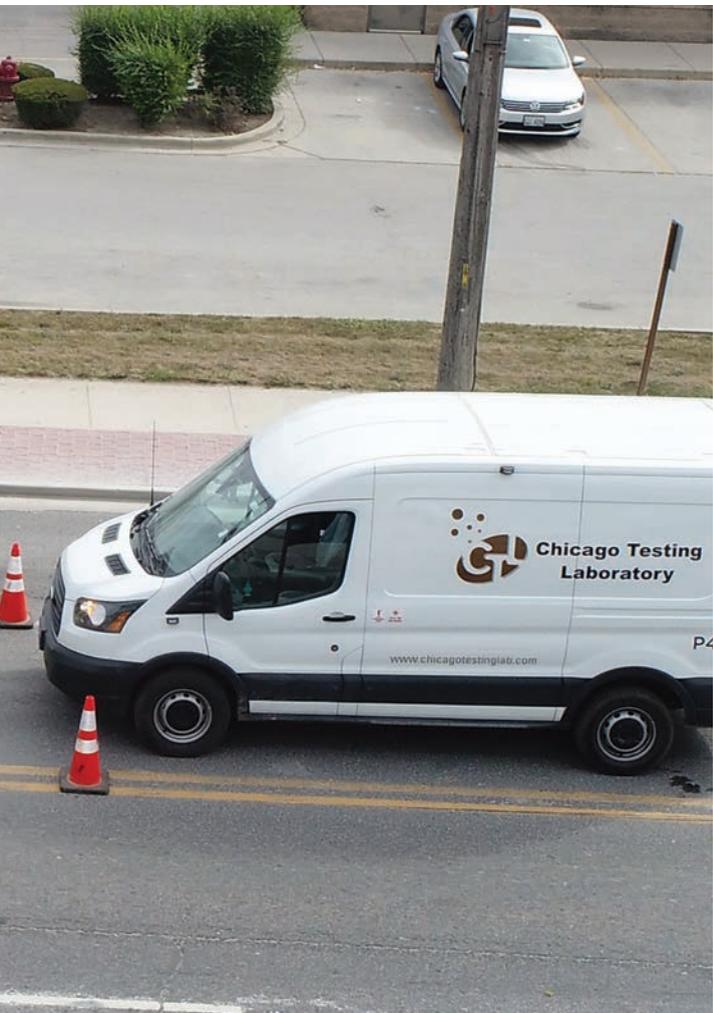
The cross-section photo of the pavement (above) shows that the reflective cracks from the old joints in the original PCC pavement did not migrate through the two new layers of SMA, even after twenty years. Giving special attention to these areas at Williams and Margaret ensured that the highly-stressed areas of the pavement delivered the same outstanding performance as mainline asphalt. During the Illinois Asphalt Pavement Association's Annual Meeting, IDOT District 1 Materials Engineer George Houston stated that the intersection has appeared to tame both rutting and cracking challenges.

As a result of the analysis, the experts determined that a previously placed asphalt overlay had not failed, but instead found the older mix below it showed signs of serious deformation to a depth of approximately six inches. IDOT decided to mill the existing intersection pavement full-depth to ensure that the new mix would be placed on a solid foundation.

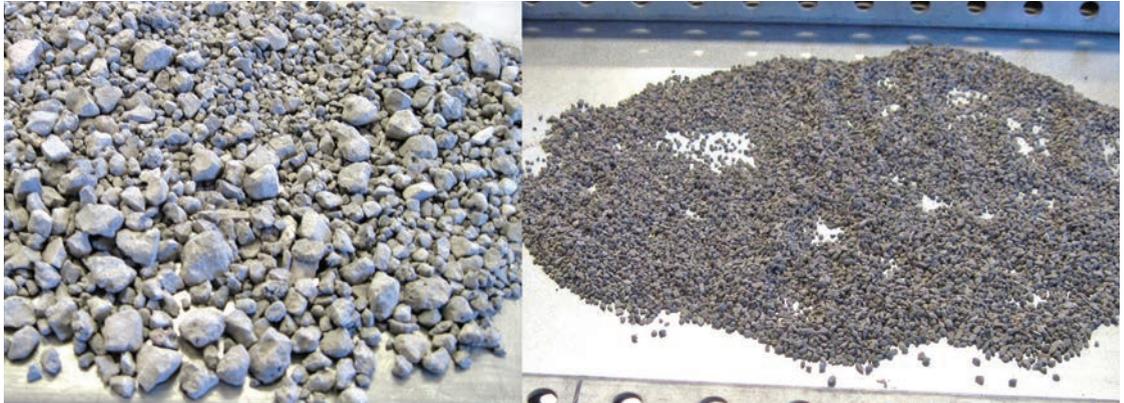
Material separation

While it feels good to develop and deliver a project that is expected to perform over a longer period of time, how do you know if you have succeeded? You reassemble the same team 20 years later to perform the forensics to understand what performed well over the intervening years. The Illinois Department of Transportation (IDOT) did just that bringing back the original contractor, Gallagher, and consultant test company, Chicago Testing Laboratory (CTL). IDOT and CTL performed forensics on recovered asphalt for Performance Grading (PG) and penetration testing, mixability and flow testing, Hamburg Wheel Testing, I-FIT, in-place density, asphalt content and gradation. Edw. C. Levy Co. performed a steel slag pick via magnetic separation.
